TIEDOWN AND BENCH TESTING OF GREASE-LUBRICATED HELICOPTER TAIL AND INTERMEDIATE GEARBOXES

United Aircraft Corporation

Army Air Mobility Research and Development Laboratory

April 1975

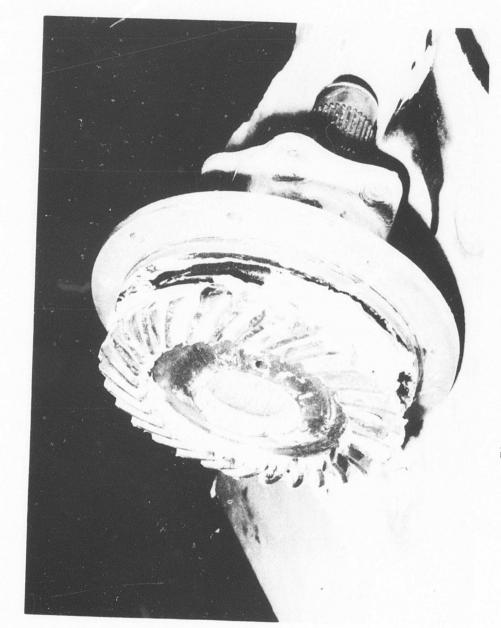
Following the tiedown test, the intermediate and tail gearboxes were completely disassembled. The inspection of the intermediate gearbox showed excellent condition of both gears and bearings. The tail gearbox exhibited similar results with one exception. Moderate scoring had been experienced on the tail gearbox spiral bevel gears. This scoring, while not typical of H-3 tail gearbox performance in production, is attributed to the high power levels, relative to prorated design, experienced during tiedown testing. The intermediate and tail gearbox components following tiedown testing are shown in Figures 7 through 12. The scoring evident on the tail gearbox gear teeth, while not typical in H-3 tail gearboxes, is similar in appearance to scoring which has been experienced on spiral bevel gears of other gearboxes such as the H-53 nose gearbox and the H-3 and H-54 main transmissions. As far as can be determined, scoring of this nature has in no case resulted in gear tooth fracture.

Figure 7. Intermediate Gearbox Input Section Following Tiedown Testing.

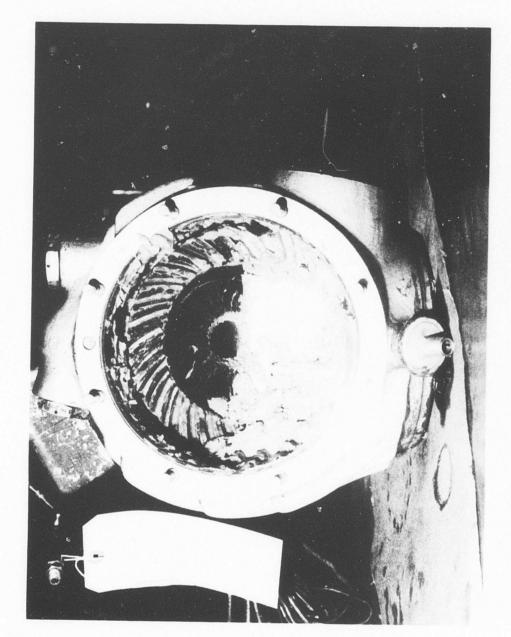
Figure 8. H-3 Intermediate Gearbox Following Tiedown Testing.

box gear teeth, the gear teeth of the intermediate gearbox had a smooth, highly polished appearance with no evidence of surface distress.

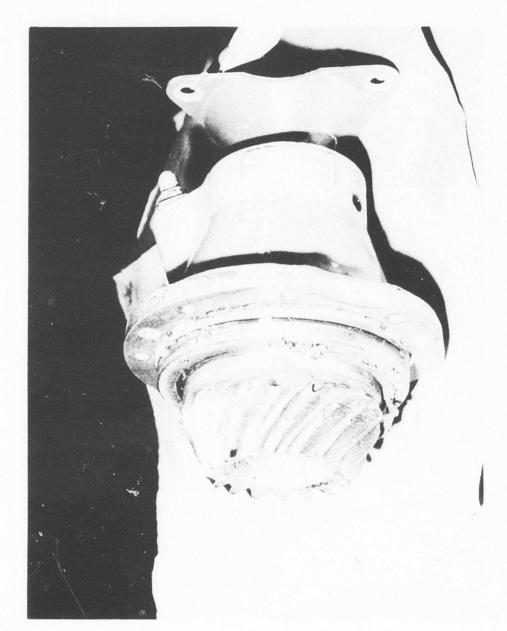
Figure 9. Tail Gearbox Input Section Following Tiedown Testing.

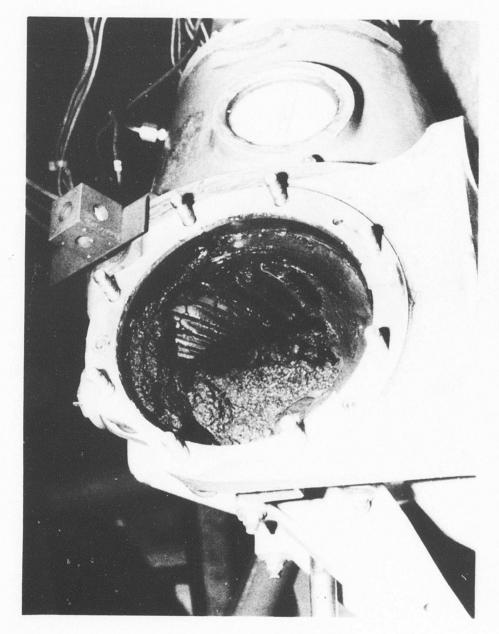
Figure 10. H-3 Tail Gearbox Following Tiedown Testing.

As previously noted, aside from the scoring experienced in the tail gearbox, no significant deterioration of the gearbox components could be detected. The grease in the tail gearbox showed a slight darkening in color, but the consistency of the grease was apparently unchanged. No comparable color change was seen in the intermediate gearbox grease. An investigation by the U. S. Air Force Materials Laboratory has determined that the darkening in color of the grease is largely the result of exposure to heat and mechanical working. The color change of the grease is not considered to indicate any degradation of its lubrication characteristics. As opposed to the slight scoring found on the tail gear-

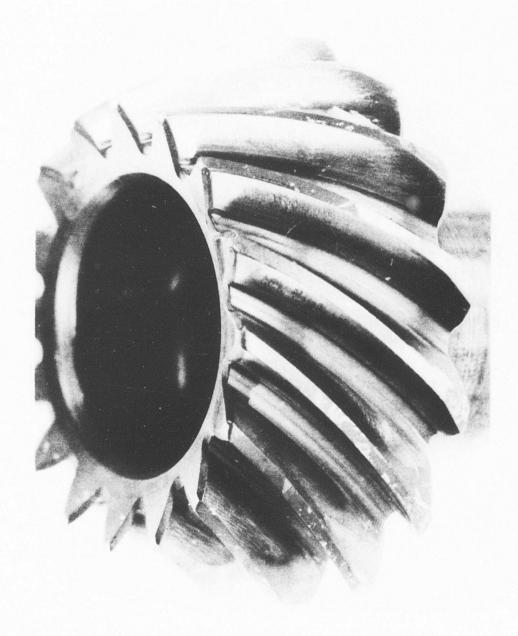
Figure 11. Tail Gearbox Input Gear Following Tiedown Test - After Cleaning.

In order to determine whether the scoring of the tail gearbox gear teeth could have been seriously detrimental to aircraft operation, both the input and output gear shafts were magnetic particle inspected following the visual inspection. The magnetic inspection revealed no indication of the formation of any cracks.

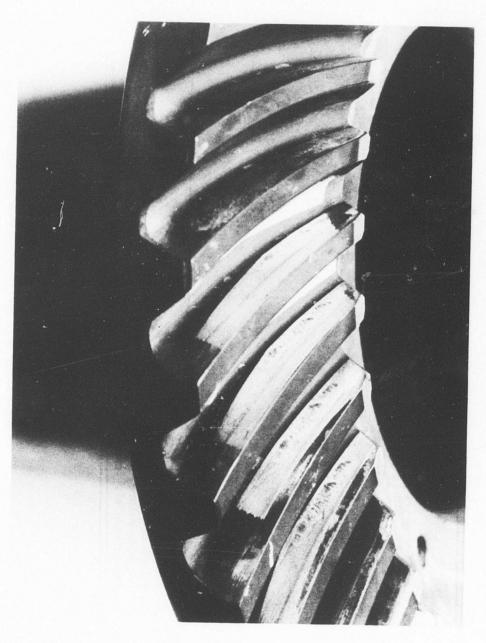
Figure 12. Tail Gearbox Output Gear Following Tiedown Test - After Cleaning.

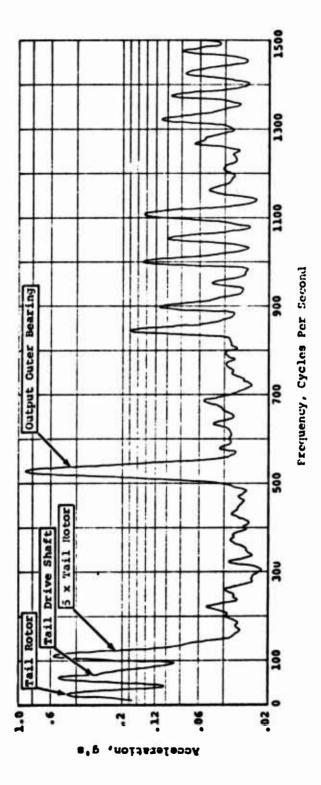
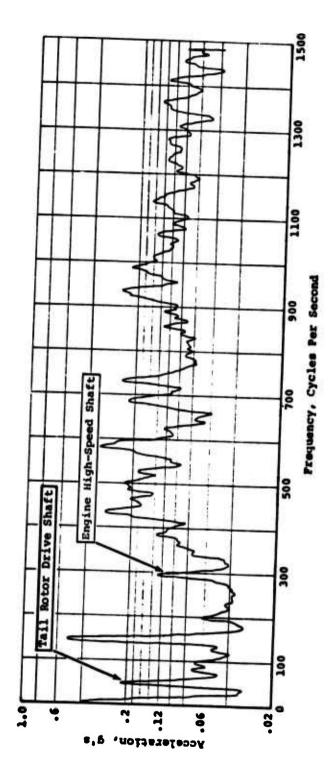
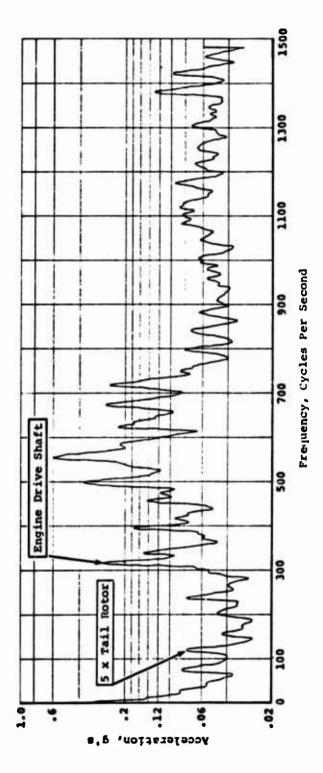
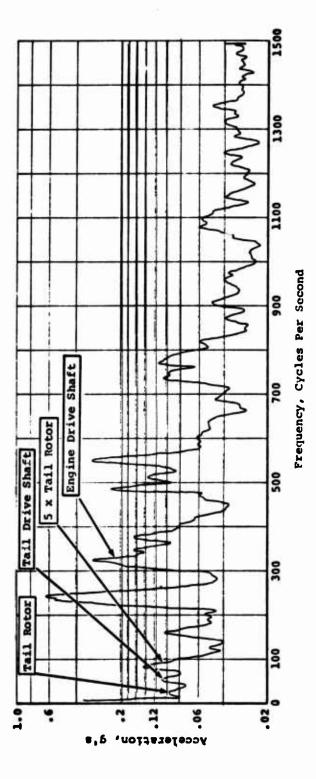
Plots of the frequency spectra are shown in Figures 13 through 16. It is seen that a change in both the amplitude and nature of the vibration occurred during the course of the test. This change was also noted on oscillograph traces as a change in waveform. The general vibration levels showed an increase for the intermediate gearbox with test time. This could indicate a possible component deterioration if vibration monitoring were to be used as an indication of component condition. However, no detectable deterioration of the intermediate gearbox occurred. Based on these observations and the general lack of a vibration data base for these gearboxes, it is apparent that a considerable amount of work needs to be performed before vibration monitoring can be considered a viable solution to grease-lubricated gearbox failure detection.

Figure 13. Intermediate Gearbox Vibration Spectrum After 3 Hours of Tiedown Testing.

Figure 14. Intermediate Gearbox Vibration Spectrum After 42 Hours of Tiedown Testing.

Figure 15. Tail Gearbox Input Vibration Spectrum After 34 Hours of Tiedown Testing.

Figure 16. Tail Gearbox Output Vibration Spectrum After 37 Hours of Tiedown Testing.

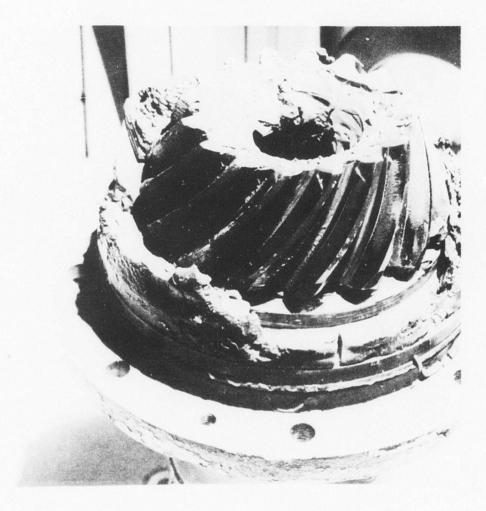
After the initial 4-hour run at 200 hp, the tail gearbox was disassembled and inspected. The gear teeth were found to have a smooth, highly polished appearance with no evidence of scoring. The gearbox was then reassembled and an additional 20 hours of testing was conducted at the 200-hp power level. Inspection following this test run showed no change in the appearance of the gear teeth. Operation at the 250-hp level was then begun. After 4 hours of operation, the gear teeth showed evidence of very slight initial scoring. An additional 20 hours of testing was conducted at 250 hp. After this 20-hour run, the gear teeth showed a scoring condition which, while still considered to be slight, was noticeably more severe than that evidenced after the 4-hour run. The condition of the gear teeth following the 20-hour test is shown in Figure 17. It should be noted that the scoring at this point was evenly distributed across the gear tooth contact pattern. The power level was then increased to 300 hp, and the test gearboxes were operated for 4 hours at this condition. This was followed by a disassembly inspection that revealed that the gear tooth scoring had progressed in severity. The condition of the gear teeth is shown in Figure 18. It can be seen that the overall scoring was somewhat heavier than it was prior to the 250-hp test run. In addition, a narrow band of more severe scoring was present in the center of each gear tooth face. This is typical of scoring resulting from heavy loads since the pattern of the spiral bevel gear teeth was developed for maximum contact stresses in the center of the tooth face. All of the scoring experienced on the tail gearbox gear teeth occurred during the recess action of the

gear teeth. This is apparent since the scoring is present only in the addendum of the pinion and the dedendum of the driven gear. This may be at least partially due to the fact that the sliding velocity in recess action is significantly greater than that in approach for this gear set. The sliding velocity at the final point of contact is 1403 ft/min as compared to 775 ft/min at the initial point of contact. The higher sliding velocity would tend to generate greater instantaneous temperature increases in the recess portions of the gear mesh and hence would have a greater adverse effect on the lubricant film.

Figure 17. Tail Gearbox Input Gear After 24 Hours of Operation at 250 hp.

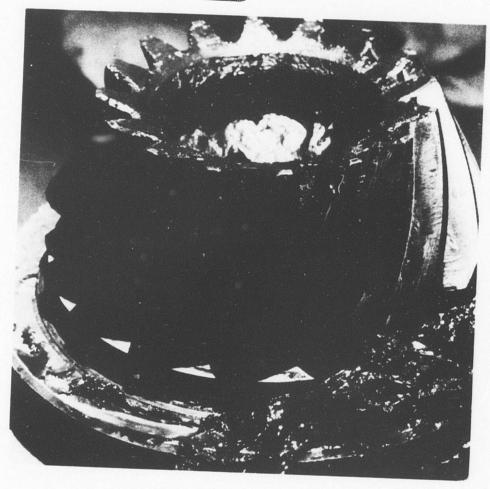
Figure 18. Tail Gearbox Input Gear After 4 Hours of Operation at 300 hp.

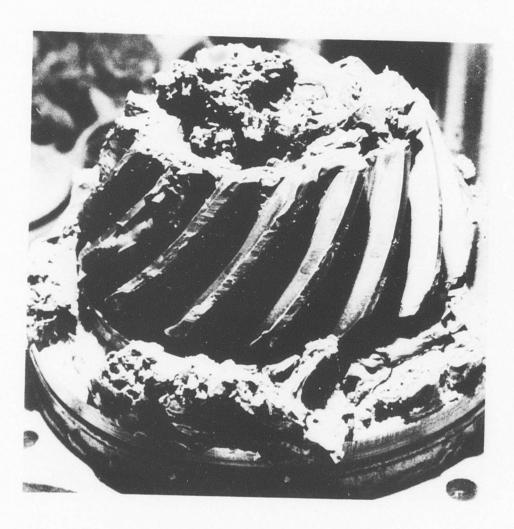
Following the testing through the 300-hp power level, a decision was made to run at a lower power to determine whether this would have any healing effect on the gear tooth surfaces. The tail gearbox was reassembled and operated at 100 hp for 4 hours. Inspection at the end of this test run showed no detectable change in the condition of the gear teeth. The previously experienced scoring was still present, and no noticeable healing had taken place. The input pinion gear teeth are shown following the low-power run in Figure 19.

Figure 19. Tail Gearbox Input Gear After 4 Hours of Operation at 100 hps.

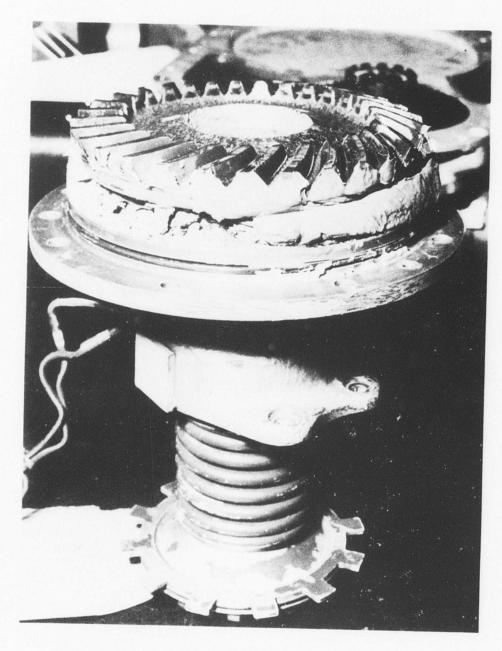
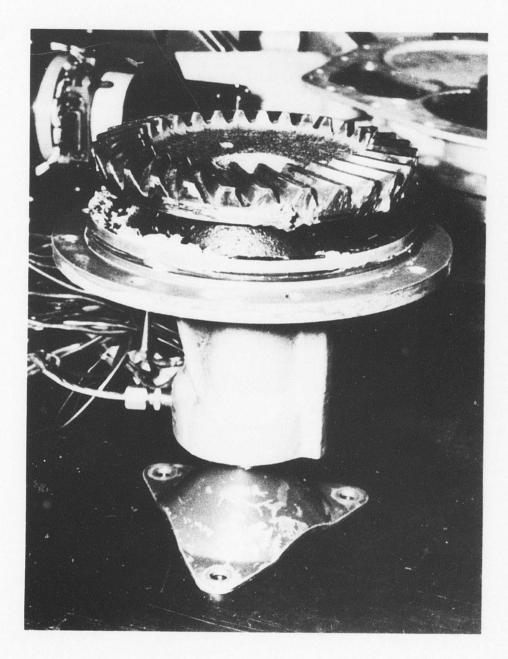
At the conclusion of all the scoring tests, the intermediate gearbox was disassembled and inspected. The gear teeth showed slight evidence of initial scoring in the central portion of the tooth. This was the first time in all of the testing performed to date that scoring had appeared in the grease-lubricated H-3 intermediate gearbox and is at this point unexplained. The grease in the intermediate gearbox had a smooth consistency with a slight darkening and showed no evidence of physical degradation. The gearbox input and output sections are shown in Figures 20 and 21.

Figure 20. Intermediate Gearbox Input Gear Following Scoring Tests

Figure 21. Intermediate Gearbox Output Gear Following Scoring Tests
